**KATY LAKE DAM**

**CALLAWAY COUNTY, MISSOURI**

**MO. 11048**

**PHASE 1 INSPECTION REPORT  
NATIONAL DAM SAFETY PROGRAM**

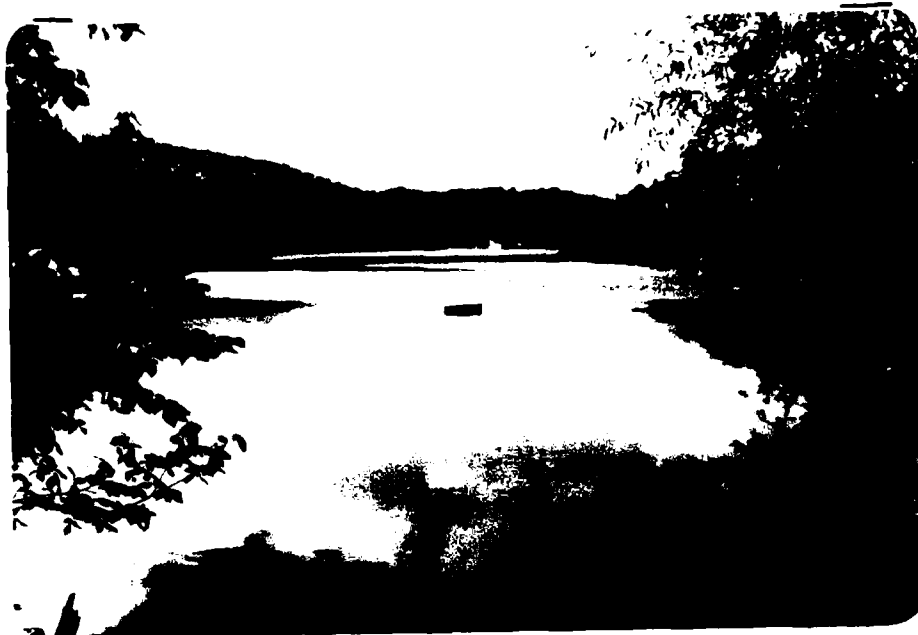
The condition of the intake tower could not be determined nor could it be determined at what level the water is

PHOTO NO. 6 - VIEW UPSTREAM FROM STATION 2+00.  
INTAKE TOWER IN CENTER.
